# Hydrology Overview North Portion of DC Ranch

J. DAVID DEATHERAGE, P.E. SENIOR CIVIL ENGINEER-PRESIDENT COPPER STATE ENGINEERING, INC.

DC Ranch Community Council December 7, 2020

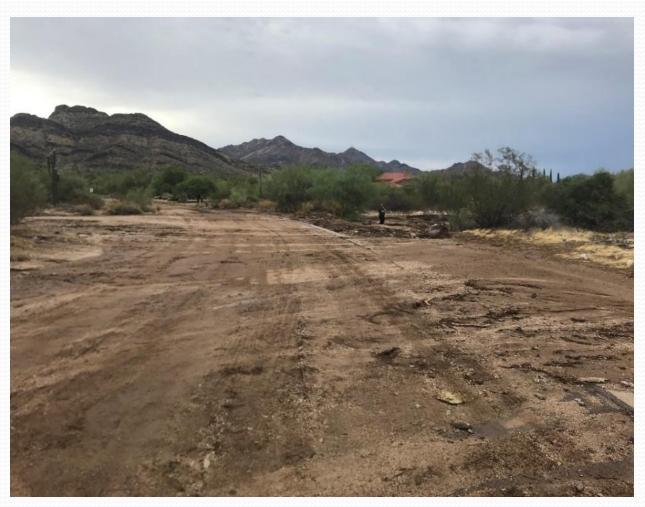
# 9-23-2019 Pinnacle Peak Vistas storm damage along E. Adobe Drive. Two-year storm?

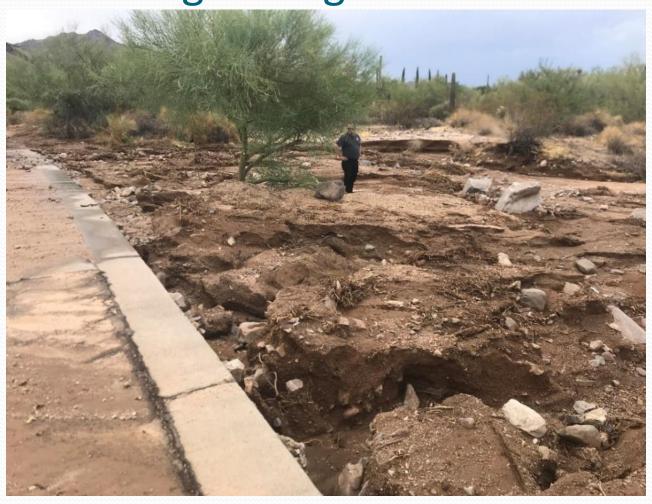
# 9-23-2019 Pinnacle Peak Vistas storm damage along E. Adobe Drive

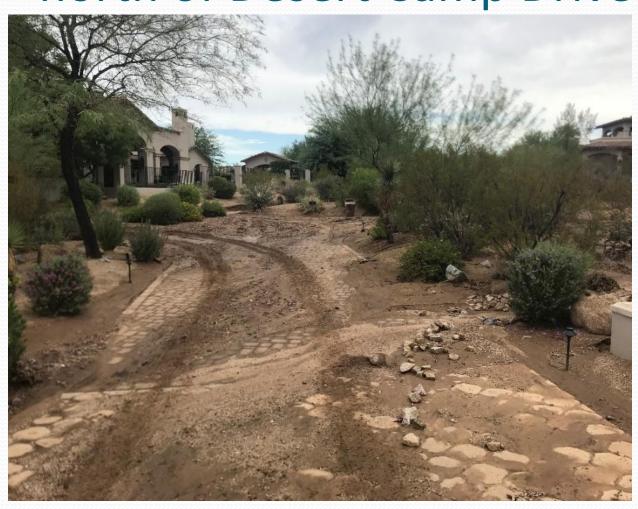
# 9-23-2019 DC Ranch storm damage north of Desert Camp Drive

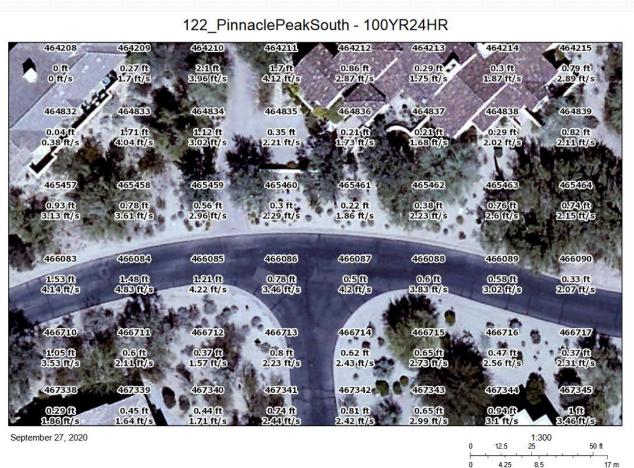
# Current Conditions along Cattle Whip Drive (PPS model-flow depth and velocity)

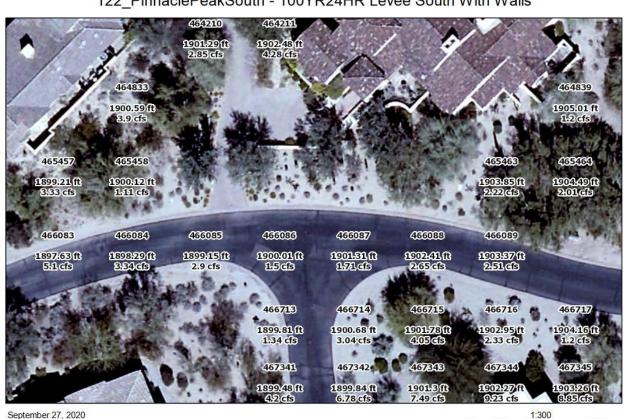
# Future Levee South With Walls along Cattle Whip Drive (PPS S Levee - flow quantity)

122\_PinnaclePeakSouth - 100YR24HR Levee South With Walls
